HO-844
Charles and Margaret Kirn House
10114 Frederick Road
Ellicott City vicinity
Howard County, Maryland
Private
c. 1911

# Maryland Historical Trust Maryland Inventory of Historic Properties Form

HO-844

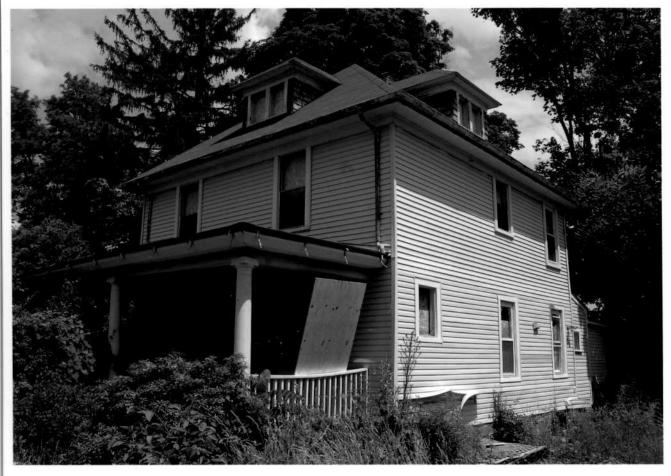
HO-0844\_20070611\_01 Southwest and southeast elevations

The house is a 2 1/2-story, two-bay by three-bay frame structure with a rubble stone foundation, vinyl siding over weatherboards on the first story and over wood shingles on the second story, and a hipped roof with asphalt shingles. The window sash are either replaced or missing. On the southwest elevation, the first story has a window to the west and a door to the south. The doorway has sidelights with one light over one panel, and a one-light transom. Both the transom bar and the doorposts are paneled. There is a one-story porch with a tongue-and-grooved wood deck, three Doric columns with railings and square balusters between them, and the soffit of the porch is now covered. The porch has a half-hip roof. The second story has two windows, and the eaves have an overhang with a bead-board soffit. There are half-round gutters. On the roof is a dormer with a hip roof and two small casements that are now missing the sash. The dormer sides are covered with wood shingles.

The southeast elevation foundation has raised-bead pointing, with a window opening over the center and east bays. The first story has a small window in the south bay and a new one-over-one sash in the center and east bays. There is a dormer that matches that on the southwest elevation. There is a wing and addition attached to the northeast in two sections. The wing has a shed roof that slopes down to the northeast, is set on brick piers with terra cotta tile infill between them, and has a small window on the southeast elevation. The addition is on brick piers and has a roof that slopes down to the northeast on the northeast part and slopes down to the southeast on the southeast part. The addition has no opening on the southeast elevation. The northeast elevation has a boarded-up door to the east and a window to the north. There is a brick chimney in this addition, and it has been heightened. The northwest elevation of the addition has a window in the center. The northeast elevation of the main block has a cellar bulkhead in the north bay of the foundation. The first story has a window in the north bay, and the second story has two window openings. The wood shingles of the story have a kick where they meet the first story, with an ogee moulding below this kick. There is a brick chimney in the center. The northwest elevation has a three-sided bay to the north on the first story, with a foundation beneath the bay and one window in this foundation. There is a window in each side of the bay on the first story, and there is a window in the center and the west bays. The foundation has a window in the center bay, and the west bay is covered with corrugated metal. The second story has three windows, and there is a typical dormer on the roof.

HO-844 Charles and Margaret Kirn House 10114 Frederick Rd. Howard County, MD Ken Short June 2007 MD SHPO Southwest and Southeast Elevations

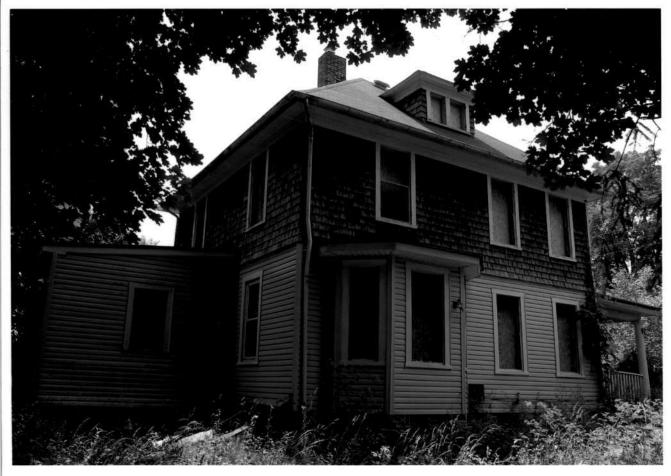
HO-0844\_20070611\_02 Northeast and northwest elevations

HO-844 Charles and Margaret Kirn House 10114 Frederick Rd Howard County, MD Ken Short June 2007 MD SHPO Northeast and Northwest Elevations

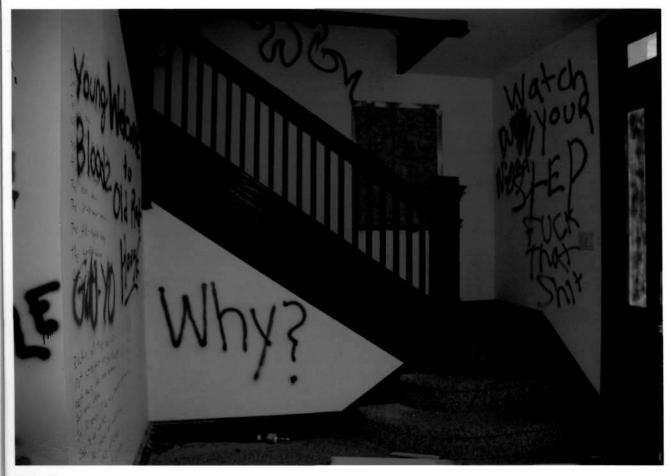
HO-0844\_20070611\_03 South room, stairway, view southeast

The interior has a four-room plan with the entrance stair hall in the south corner and rooms in the west, north, and east corners. The south room has a stair on the southeast wall that has three runs. It ascends along the southwest wall to the southeast, then along the southeast wall, and finally along the northeast wall. The stair has a paneled, closed stringer, with a sunken, flat panel and a bolection mould with a torus and a cavetto and bead. The stair has square balusters of oak, and a moulded handrail that also appears to be pine. There is a square paneled newel post of oak that has dentils at the top. All of this woodwork has a dark stained finish. The floor is carpeted, and the baseboard has a quirked ogee and bevel. The front door has one light over a pair of lying panels, above one lying panel, with a pair of lying panels at the bottom. The door has been broken apart. The architrave has an ogee backband and a beaded interior edge. The interior doors are missing, and the architrave has a broken double field and a cavetto at the break and a small ogee on the inner edge.

HO-844 Charles and Margaret Kirn House 10114 Frederick Rd Howard County, MD Ken Short June 2007 MD SHPO South room, Stairway, View Southeast

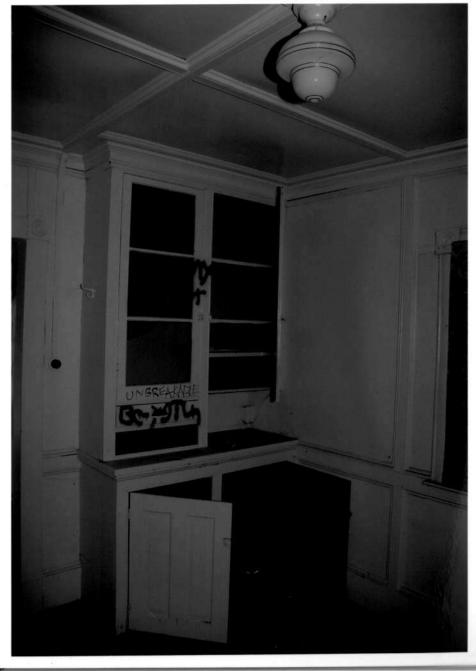
HO-0844\_20070611\_04 Northeast addition, cabinet

The northeast addition has carpeting, and the walls have Masonite with applied rails and stiles and panel moulds to create the effect of paneling. The panel moulds have a quirked ogee and bevel. The architrave is in part plain with bull's-eye corner blocks, and in part pulvinated with a torus on each side and the same bull's-eye corner blocks. The ceiling is treated like the walls with an ovolo and cavetto cornice mould. There is a chimney on the east with a stovepipe hole. On the southwest wall is a cupboard with two doors that have three lights each on the top. The south side has two drawers below the door while the west side is open below the door, though it was possibly altered. There are two doors at the bottom of the cupboard, each door having two panels with sunken fields and panel moulds. The doors have butt hinges with pins and spring catches. The south elevation has two doors. The east door has one light over two lying panels, with butt hinges that have ball finials. The south door has four panels with sunken fields and ogee panel moulds. The center of the wall, beneath the Masonite, has weatherboard siding to the south with a seam, and it is painted dark green. To the east there is patched wood sheathing. The south door leads to a powder room, while the east door leads to a closed-off vestibule. This vestibule has beaded-edge, vertical-board half wainscot and two four-light casement windows on the southeast. There is a window opening on the southwest, and a door on the northeast that has one light over two panels. The ceiling has narrow beaded-edge-and-center boards.

HO-844 Charles and Margaret Kirn Honse 10114 Frederick Rd. Howard County, MD Ken Short June 2007 MD 5HPO Northeast Addition, Cabinet

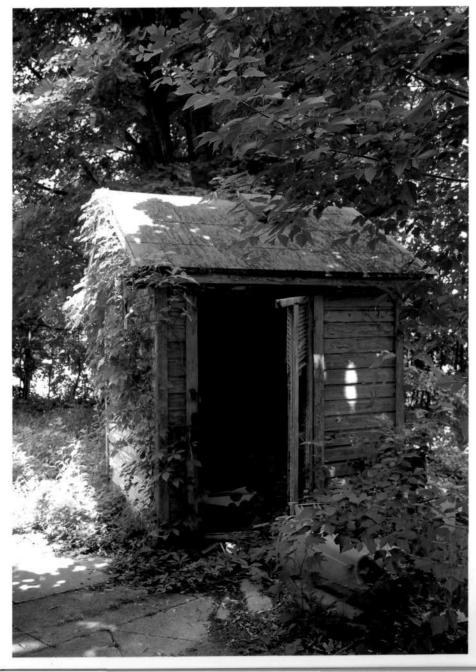
HO-0844\_20070611\_05 Outbuilding, southeast elevation

There is a shed located about 5 feet northeast of the addition to the house. It is a one-story, one-bay structure with German siding and a gable roof with flat metal and a southwest-northeast ridge. The building has a wood box cornice with returns. The southeast elevation has a door with louvered blinds though this has been broken. The northwest elevation has a six-over-six sash with head-cut trim. There are no openings on the northwest and southeast elevations. The interior of the building has exposed 2 by 4 studs.

Charles and Margaret Kirn House 10114 Frederick Rd. Howard County, MD KenShort June 2007 MD SHPO Outbuilding, Southeast Elevation HO-844, House 10114 Frederick Road, Ellicott City vicinity Howard County Ca. 1910 Private

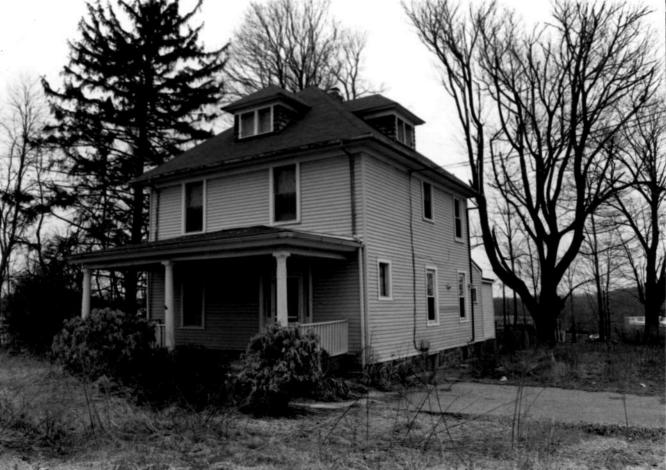
The east side façade has three windows across the first story and two windows on the second story. Three of the five openings hold vinyl windows while the other two openings are boarded up. There are two boarded up window openings in the foundation and another hipped dormer that is also boarded up.

AD-844, House
10114 Frederick Rd
Howard County, Maryland
Knoth Hill, 3/04
Negative at MOSHPO 32 21+B1 HNHNH 158
SE clevation
119

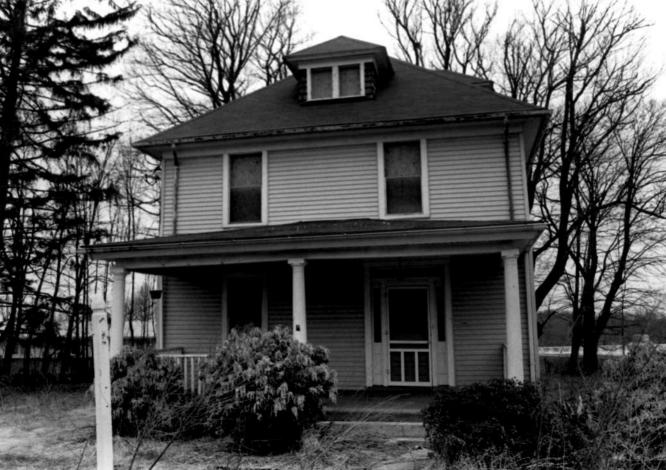
The front (south) façade is two bays wide. The entrance is located in the right bay and the glazed and paneled door is capped by a narrow transom and flanked by sidelights. The second story windows are vertically aligned above the first story openings. All of the windows on this façade have been removed and the openings boarded up. There is a hipped dormer on the front slope of the roof that originally held two casement windows which have been removed. The sidewalls of the dormer are covered with unpainted wood shingles. A single story porch spans the full width of the front façade. Doric columns support the hipped roof and square balusters ring the wood floor.

Ho.844, House
10114 Frederick Rd.
Howard Courty, Mayland
Kristin Hill, 3/04
Negative at MDSHPO 31 21+81 HHNHN 158
Front (Soruth) elevation
2/9

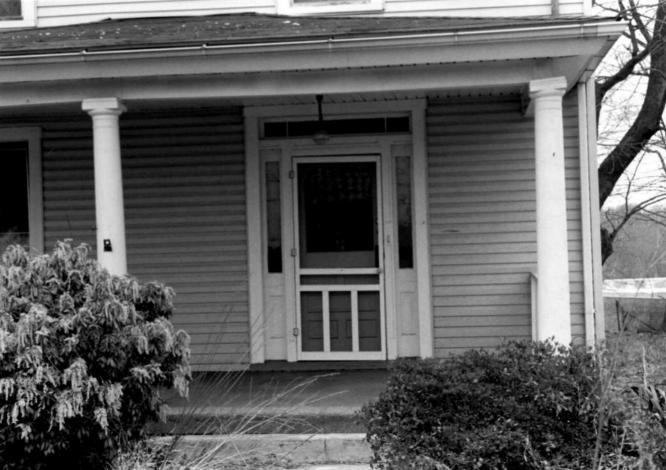
Ho.844, House
10114 Frederick Rd.
Howard County. Maryland
Kristin Hill, 3/04 30 21+00 HINNIN 150
Negative at MDSHPO
Front entrance

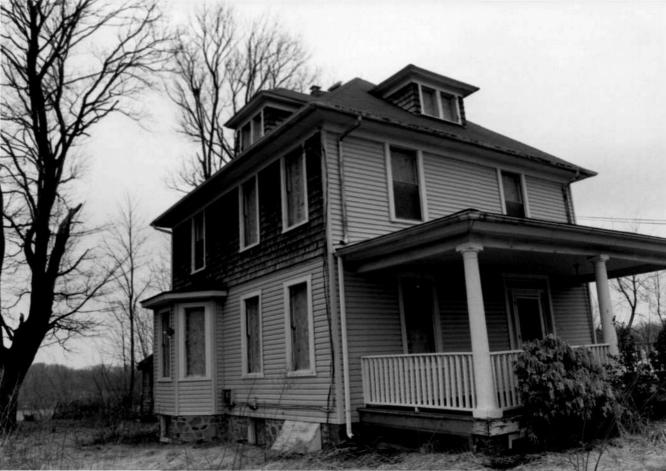
On the west side façade, the second story is shingled with unpainted wood shakes while the first story is covered with vinyl siding. There are three windows located across the second story and two regular windows and a three-sided bay window on the first story. There are two boarded up window openings in the foundation and a hipped dormer on the roof. Like the front dormer, this one originally held two casement windows that have since been removed.

Ho844, House 10114 Frederick Rd. Howard Lounty, Mayland Knstih Hill, 3/04 Negative at MDSHPO SW devation 4/9

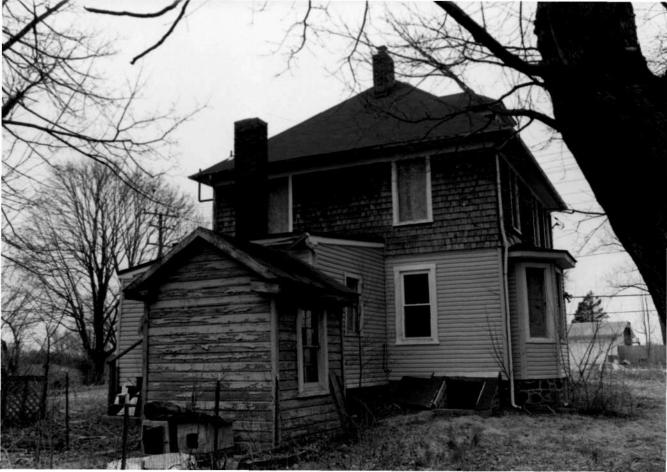
There is an early one story, shed roofed addition centered on the rear (north) façade. This addition rests on a brick foundation and has a tall interior brick chimney. Like the west façade, the second story of the original rear façade is shingled while the first story, including the addition, is covered with vinyl siding. There are two windows located on the second story, both removed, and one window located to the right of the addition on the first story. There is also bulkhead access to the basement to the right of the addition. There is an enclosed porch on the east side of the addition that conceals the rest of the first story of the original structure.

HD. 844, House 10114 Frederick Rd. Howard County, Mayland 27 21+81 MHHHM 158 Knoth Hill, 3/04 Negative at MOSHPO Kear ( north) elevation, shed in foreground 619

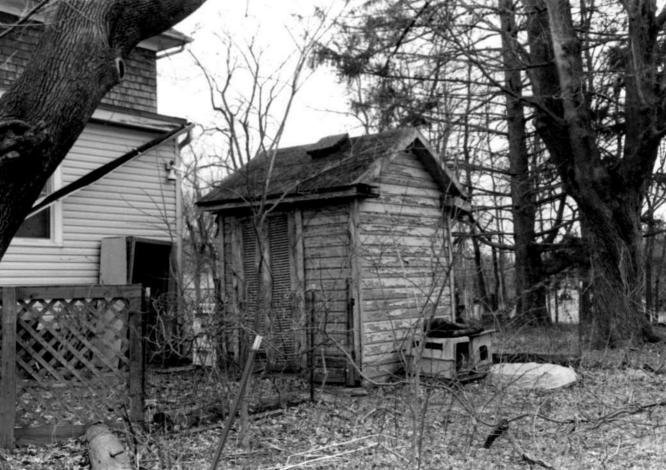
The only outbuilding on the property is a small frame shed located directly behind the addition. This shed has wooden German siding, a metal roof, one 6/6 double hung wood window on the west façade, and a door on the east façade.

HO-844, House 10114 Frederick Rd. Howard County, Mayland Knoth Hill, 3/04 Negative at MOSHPO Shed, northeast elevation 9/9
